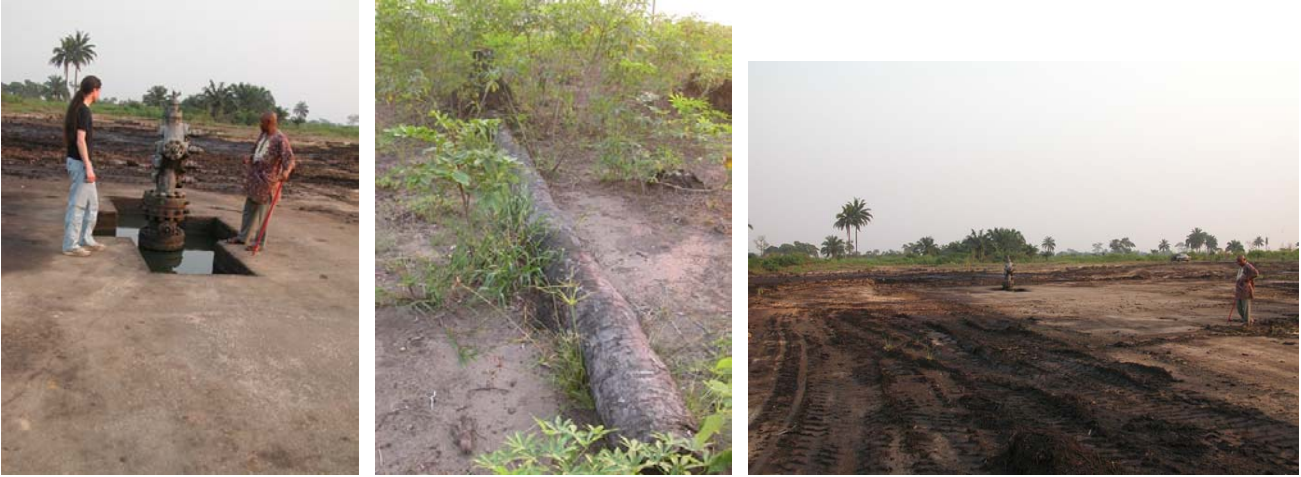
Location 15 situated within the Yorla oil field where the spill of oil and explosion which occurred on 29<sup>th</sup> March 2001 destroyed a vast area of farmland, economic trees and crops.

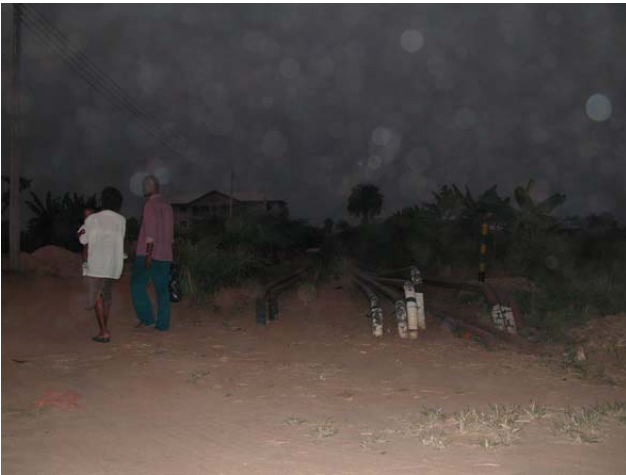
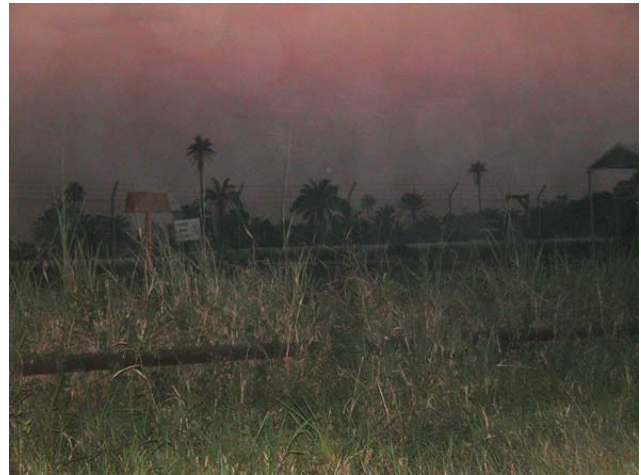
3.5 Besides the dismantling of underground pipelines, many surface pipelines still operate.<sup>33</sup> Surface pipelines are smaller and more exposed to damage by incidents. This danger is high as surface pipelines parallel roads (above surface) or cross them (below surface). Surface pipelines are therefore highly exposed to passing vehicles. All pipelines are freely accessible. This allows hired agents as well as black traders to tap the pipelines and draw crude oil (see 2.6, 6.10).

Surface pipelines near Eleme, Eleme kingdom, crossing the road below surface and paralleling it.
